WOOD DESTROYING PESTS AND ORGANISMS INSPECTION REPORT

Building No.	Street	City	Zip	Date of Inspection	No. of Pages
12	Gloucester Cove	San Rafael	94901	12/20/2012	9

General Description: **Two Story Townhouse Residence	Inspection Tag Posted: Garage
Order Number: ** 01-61345	Other Tags Posted: None

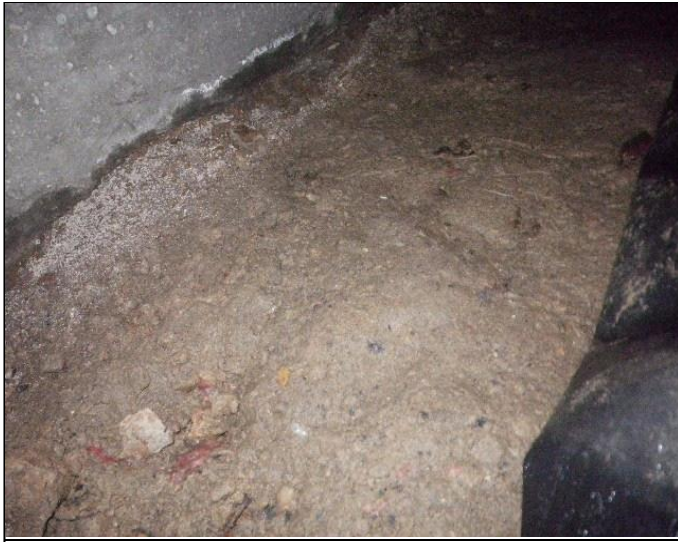
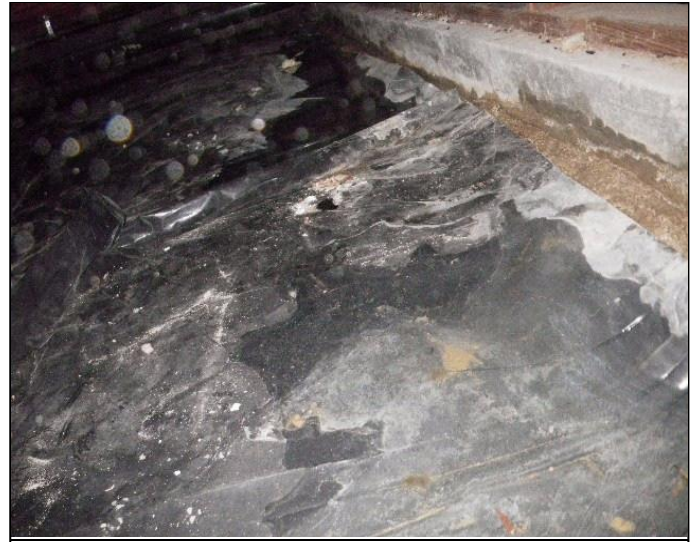
2.1 "SECTION II" The crawl space soil is damp throughout and had standing water at the right front side along the perimeter. Moisture in the substructure area promotes wood-destroying fungus growth. A moisture barrier as noted below has been installed.

Wet soil and standing water noted

RECOMMENDATION: We recommend improving site drainage and suggest contacting a soils/drainage specialist for recommendations and corrective work.
